Individual Station Report

Cos Cob

Connecticut Department of Transportation

Urbitran Associates, Inc.

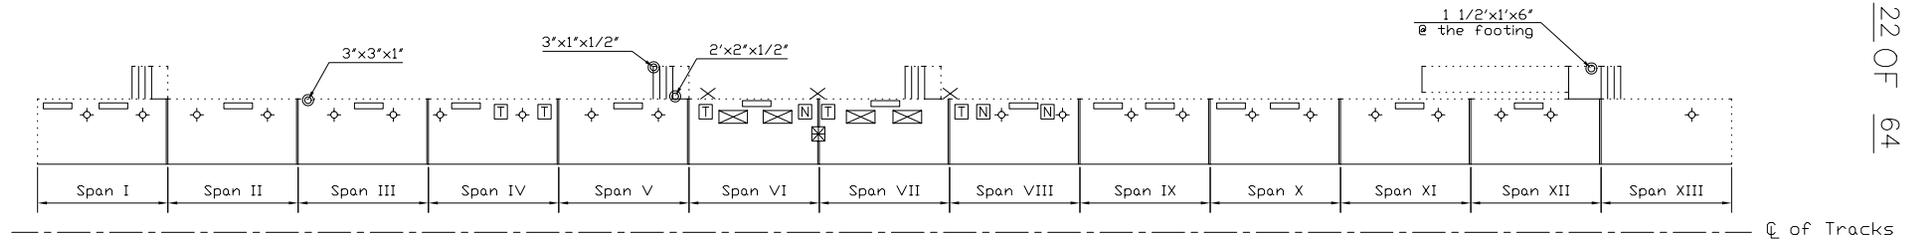
(Southbound) North Platform

1. The base plates for the double tee are rusted and deteriorated throughout the entire length of the platform.
2. The canopy in Spans VI–VIII is rusted.
3. The railing base plates are rusted and deteriorated throughout the entire length of the platform.

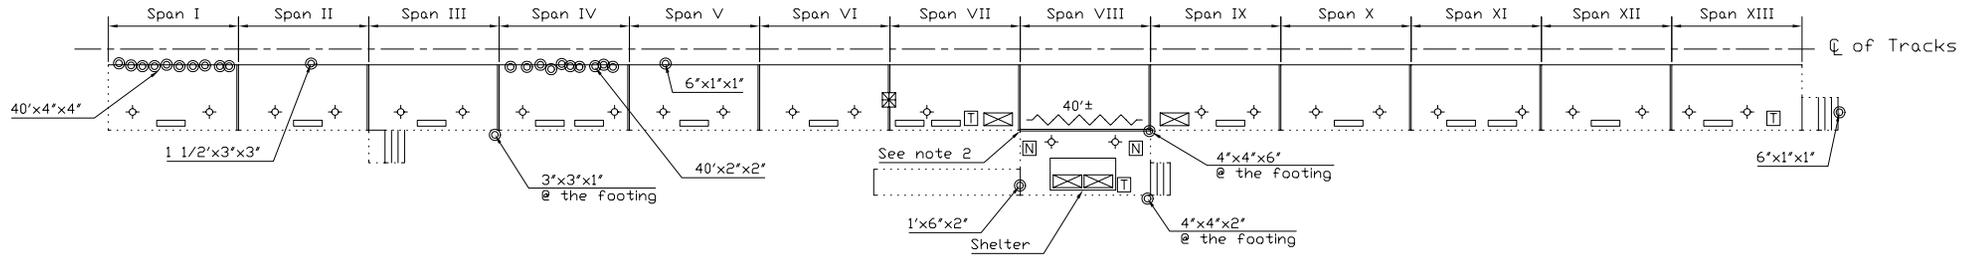
(Northbound) South Platform

1. The base plates for the double tee are rusted and deteriorated throughout the entire length of the platform.
2. There is spalled concrete with exposed steel (2'x2'x2").
3. The railing base plates are rusted and deteriorated throughout the entire length of the platform.

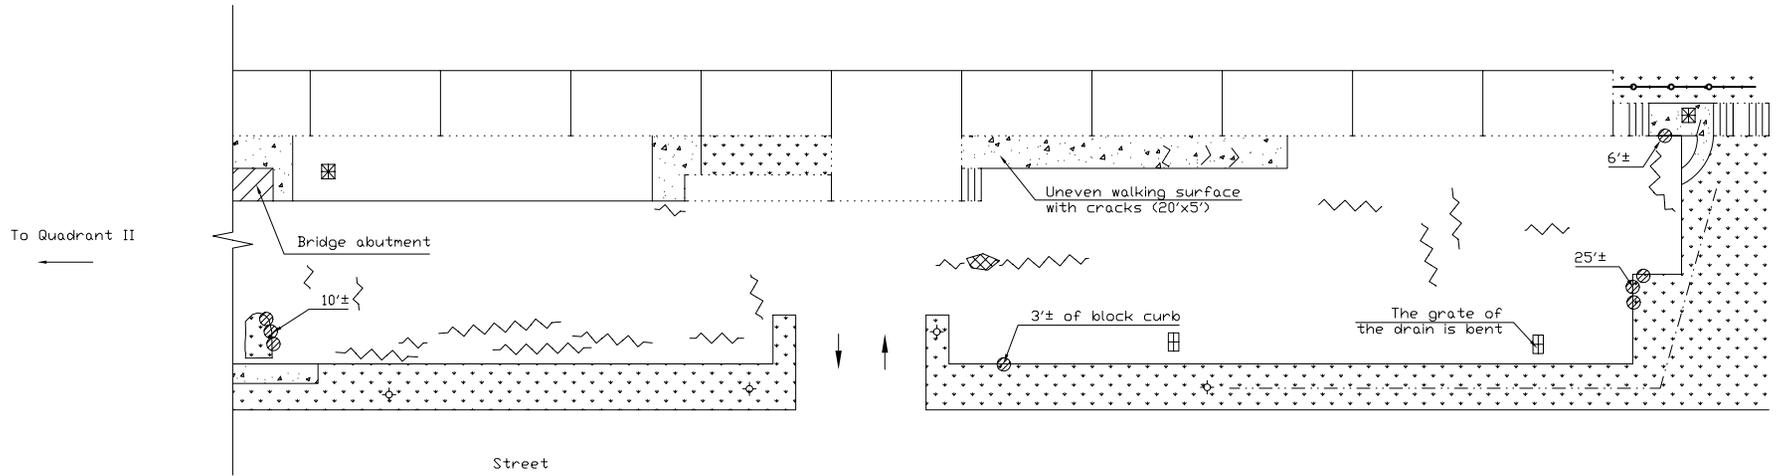
Urbitran Associates, Inc.
Connecticut Dept. of Transportation
Cos Cob Station Quadrant I (Lot 4) Plan
Date: 2/10/02

1. The asphalt surface is cracked (300'±).

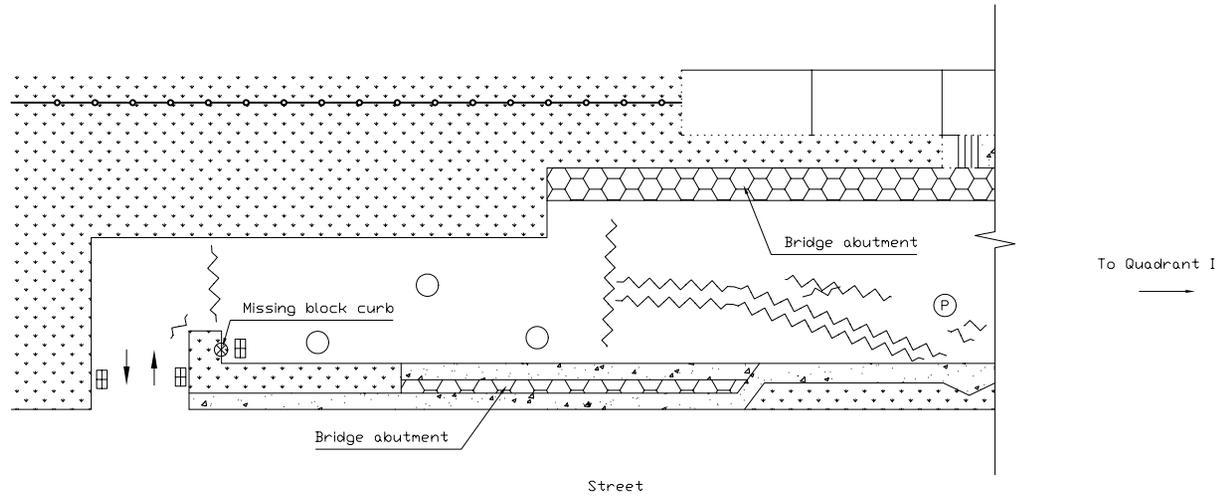
Urbitran Associates, Inc.
Connecticut Dept. of Transportation
Cos Cob Station Quadrant II (Lot 4) Plan
Date: 2/10/02

1. The asphalt surface is cracked (300'±).

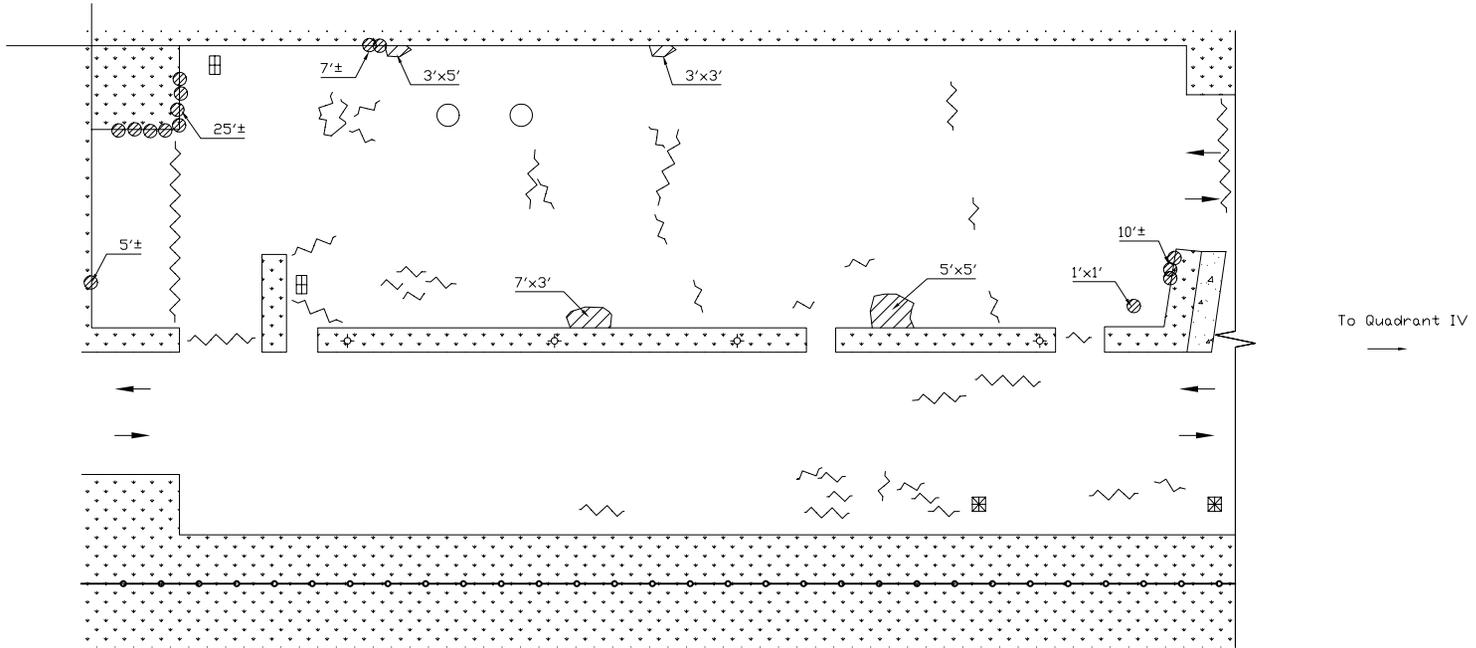
Urbitran Associates, Inc.
Connecticut Dept. of Transportation
Cos Cob Station Quadrant III (Lot 3) Plan
Date: 2/10/02

1. The asphalt surface is cracked 500'± in addition to the map cracking, and the uneven driving surface with cracks.

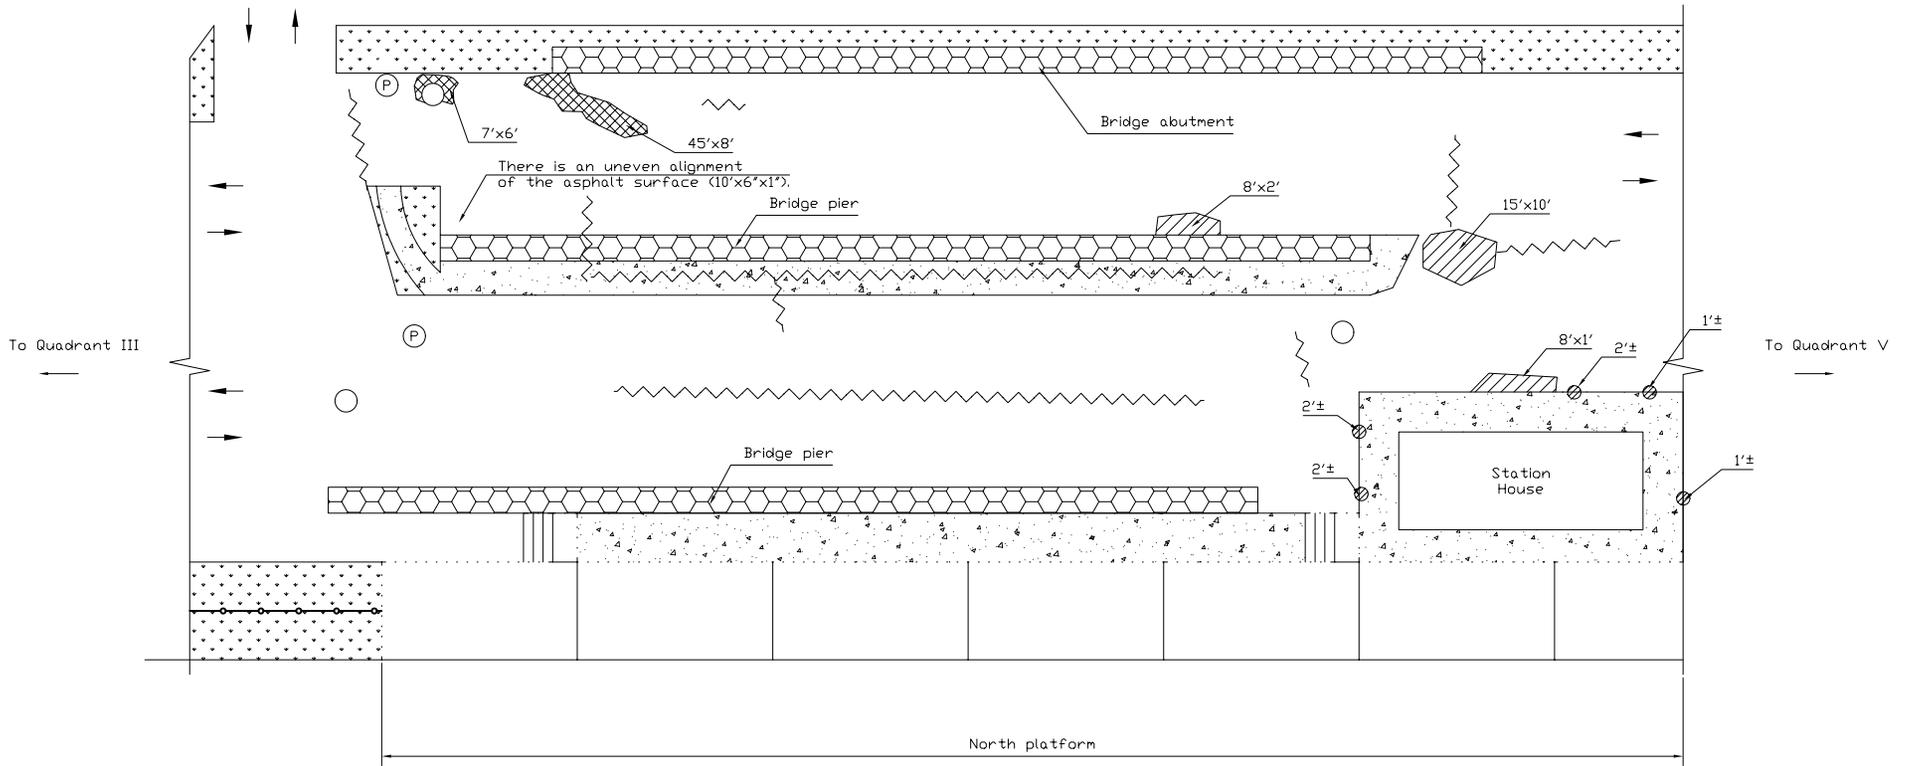
1. The asphalt surface is cracked 300'± in addition to the map cracking, and the uneven driving surface with cracks.

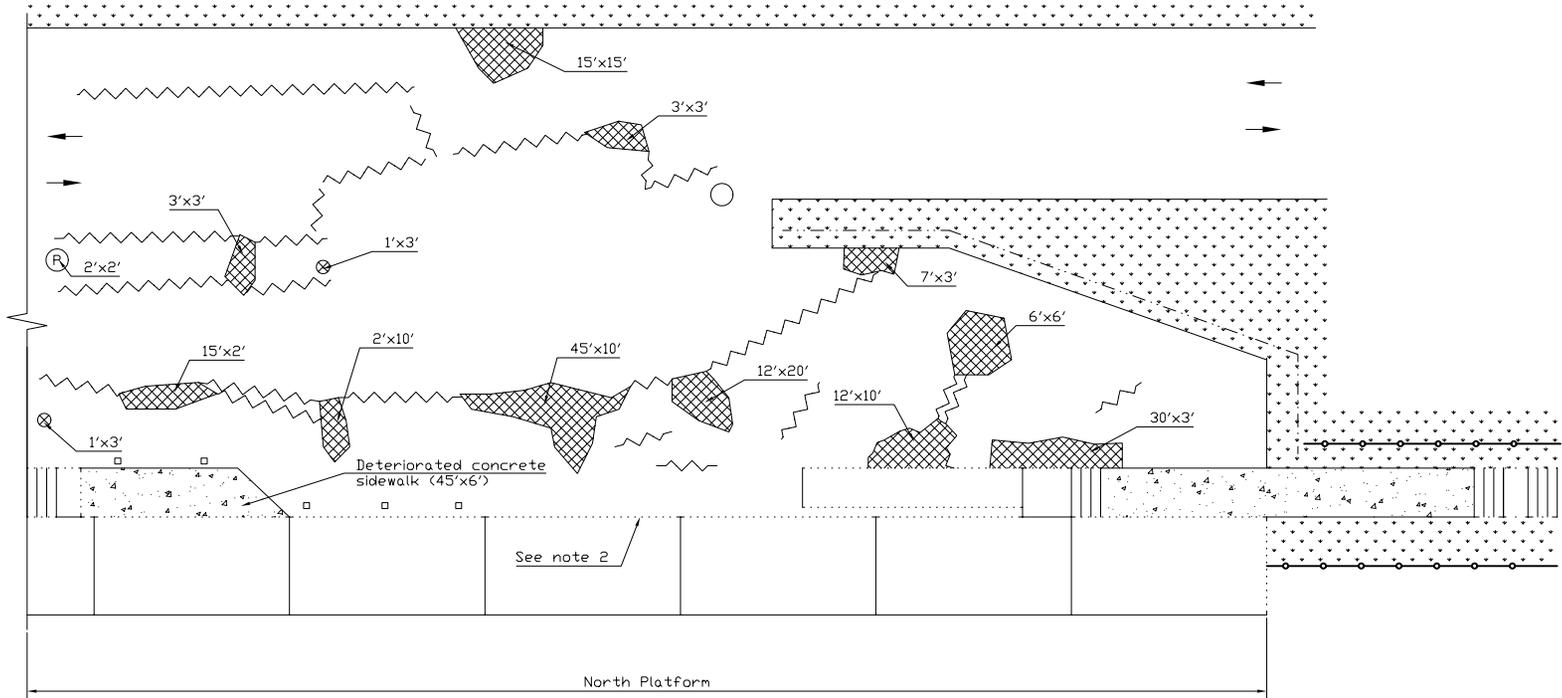
Urbitran Associates, Inc.
Connecticut Dept. of Transportation
Cos Cob Station Quadrant V (Lot 3) Plan
Date: 2/10/02

1. The asphalt surface is cracked 500'± in addition to the map cracking, and the uneven driving surface with cracks.
2. The concrete curb below the platform is spalled (240'±).

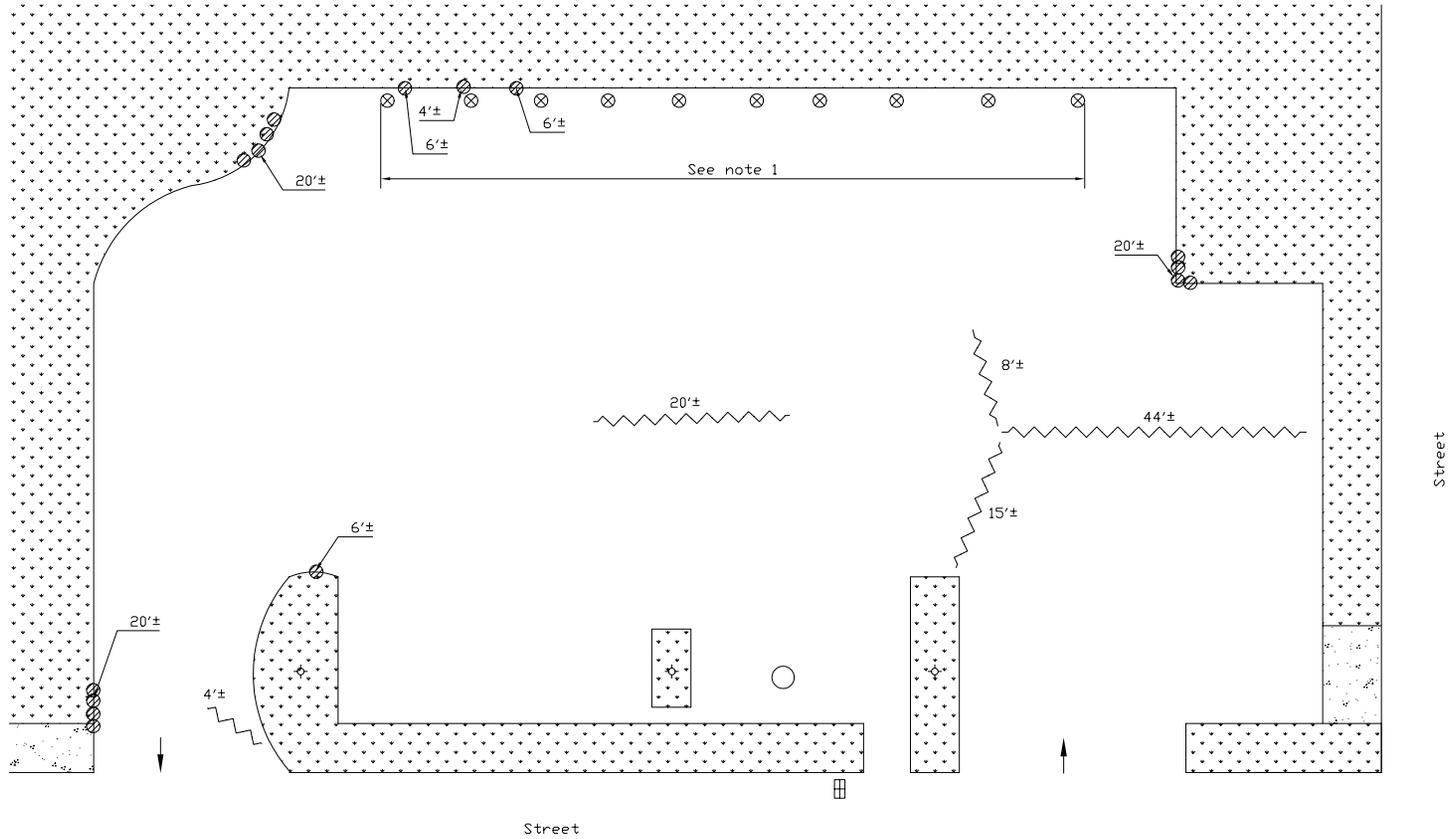
Urbitran Associates, Inc.
Connecticut Dept. of Transportation
Cos Cob Station
Quadrant VII (Lot 2) Plan
Date: 2/10/02

NOTES:
 1. There are ten areas (4'x4' each) that are missing asphalt.

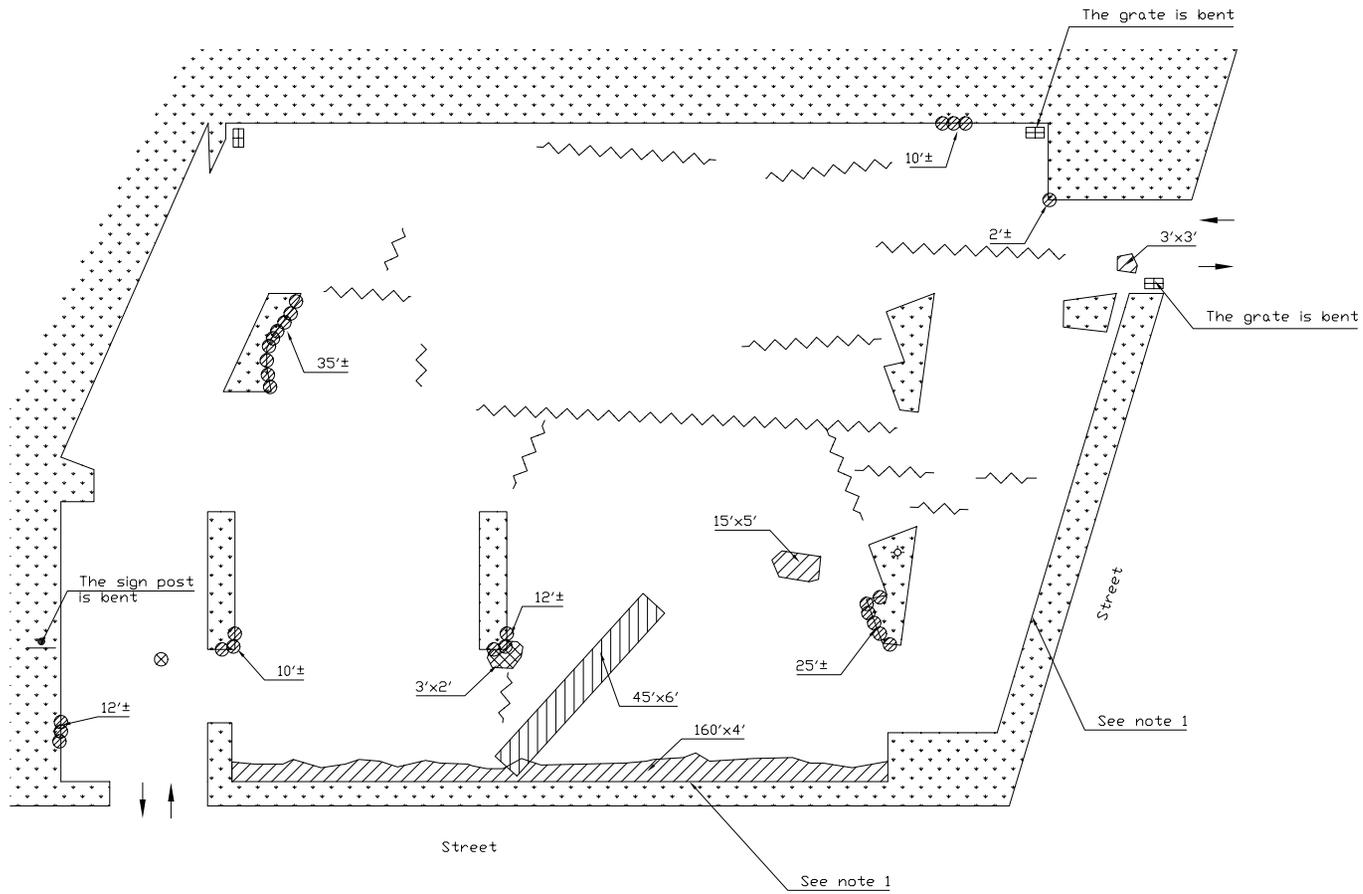
Urbitran Associates, Inc.
Connecticut Dept. of Transportation
Cos Cob Station Quadrant VIII (Lot 1B) Plan
Date: 2/10/02

1. The curb is cracked, spalled, or missing (240'±).
2. The asphalt pavement is cracked 500'± in addition to the map cracking, and uneven driving surface with cracks.

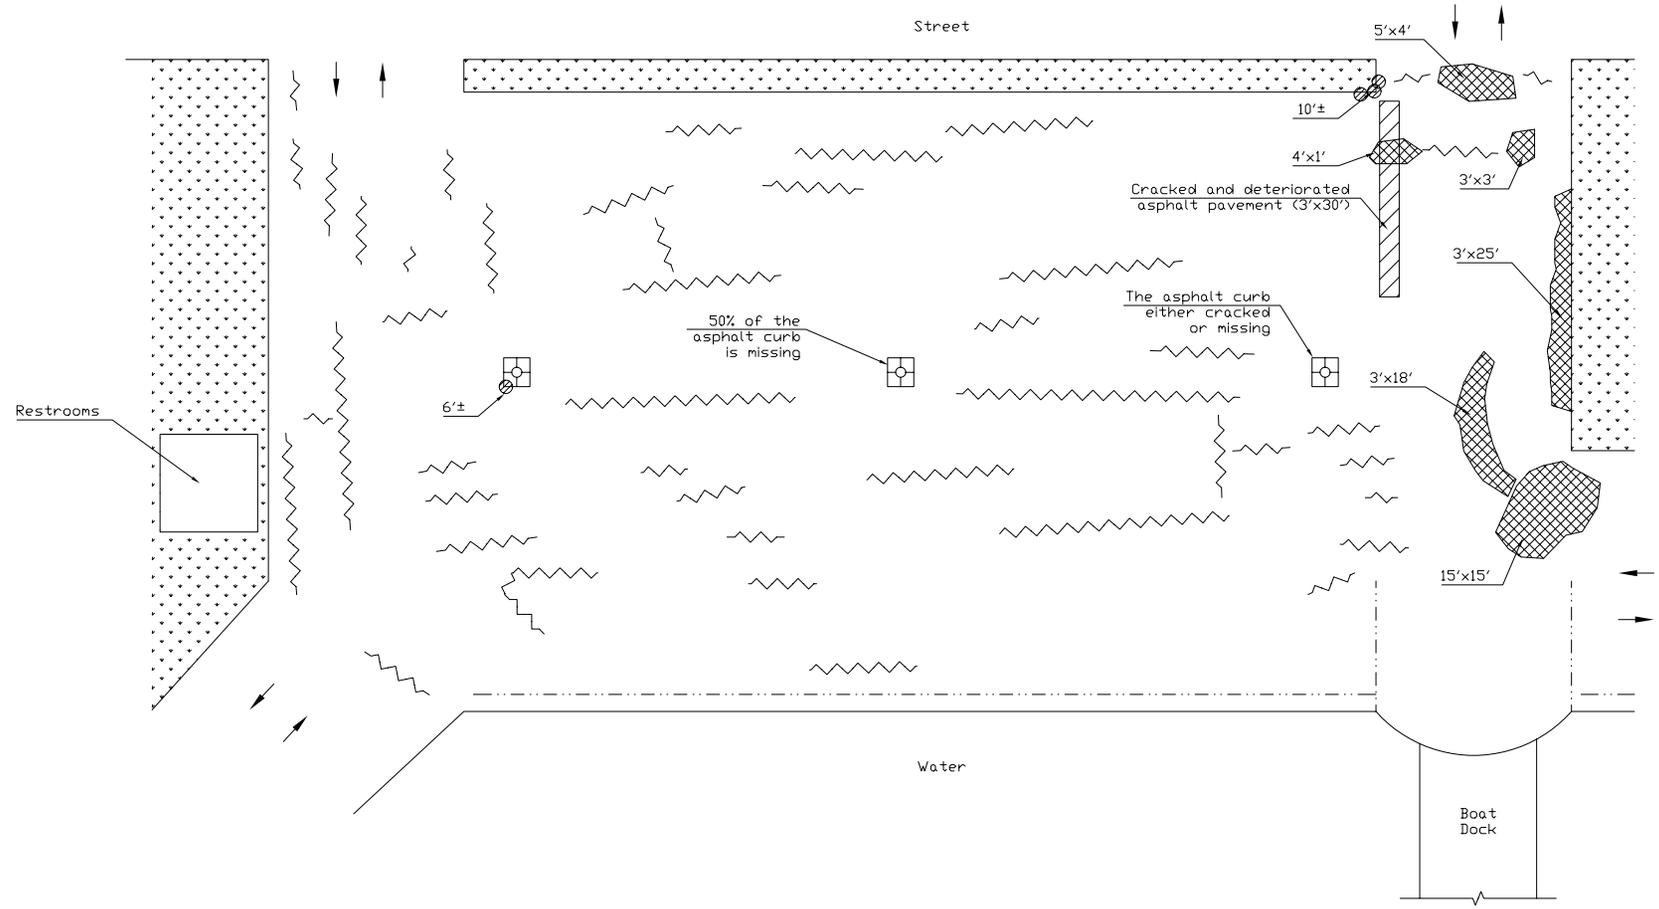
NOTES:
 1. In addition to the isolated map cracking, the asphalt surface is cracked 700'±.
